Scheme, Bridgeman Street, Walsall, highway flooding.

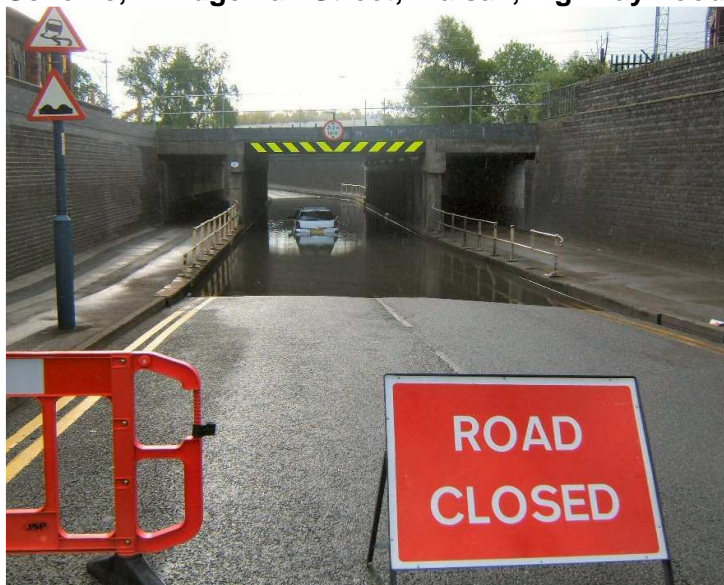
This road under a railway bridge is the lowest part of Walsall Town Centre and the area has flooded on several occasions during the last thirty years. Various studies have been done in the past to cure the problem. Pumps were installed many years ago, but they were never able to cope with the deluge of water. Several survey companies and consultants were employed over the years to find a solution without success.

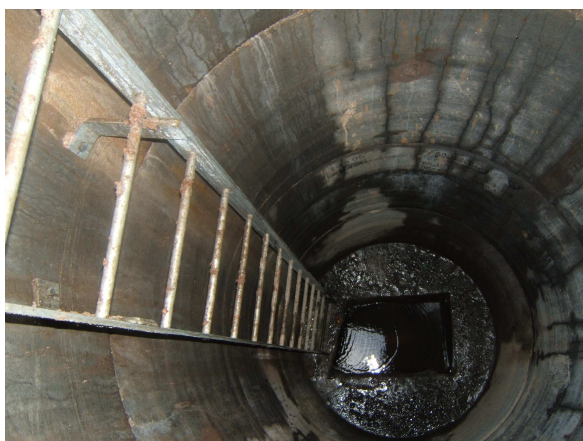
The nearest possible surface water outfall was this manhole, which was not on the sewer or railway records, yet a developer had found an old manhole on this 600mm diameter pipe, and built new manholes onto to connect his SW drainage. We later found that this is a public surface sewer not on the sewer records. However while the levels worked we could not prove the connection, as this manhole was 500m from the flood area. No one can jet that far, and the volume of water meant that dye trace would no show and silt levels prevented CCTV, STW denied a connection existed.

The next time the road flooded I took levels on the floodwater and compared them with water levels in this manhole. The above manhole, which is over 5m deep, was flooded to 2m from the cover and at the exact same level as the floodwater on the road. Severn Trent accepted this evidence and cleaned the sewer allowing flood levels to drop. Further improvement works are ongoing.
